Confidential Inspection Report

22 West Hope Street
West Chester, PA 19382

Prepared by: John J. Biegalski, ASHI Certified Inspector #200883

Alpha Check Inspections 610-992-1252

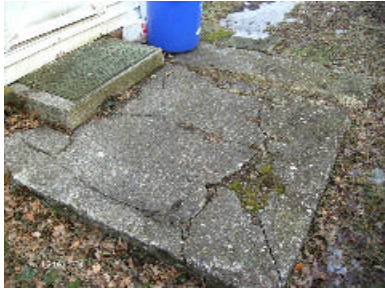
The Rear entrance stoop is deteriorated due to age. Properly repair or replace. \$150-400

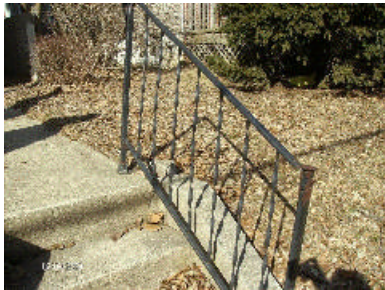
The railings servicing the front steps are deteriorated/loose. Properly repair/replace the railings as necessary. **\$350-500**

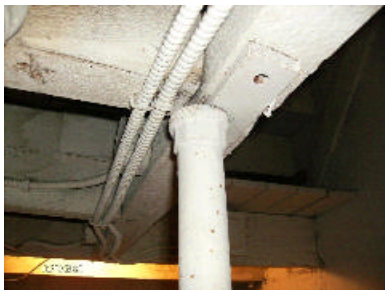
There are steel columns or posts installed that are slipping away from the plate at the top of the post. Properly realign the posts and secure them to each other. **\$100-150**

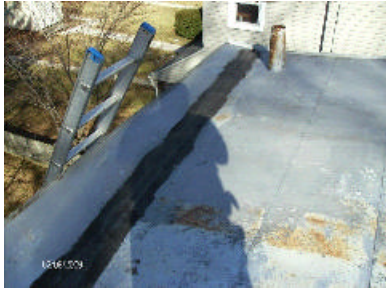
There are two metal roofs. The rear metal roof is 50+ years old and in need of maintenance. The finish coat is rusting and beginning to wear. Properly remove the rust and apply an oil based primer and finish to protect the roof. **\$500-650**

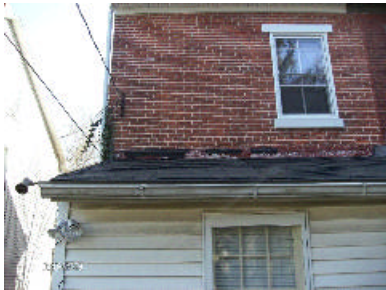
The rear counter flashing has been patched and is also beginning to rust. Repair in same manner as upper metal roof. **\$100-150**

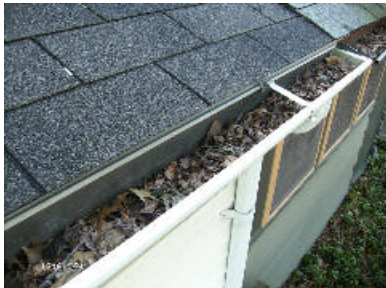
The gutters and downspouts are full of debris and overflowing at the rear of the property. Properly clean and maintain the gutters and downspouts. **\$50-60**

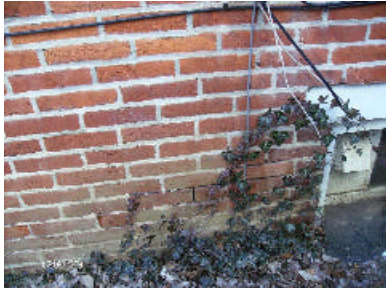
The exterior brick surfaces have minor deteriorated mortar joints at several areas. Have a masonry specialist properly repair/repoint and preserve the brick as necessary. **\$600-800**

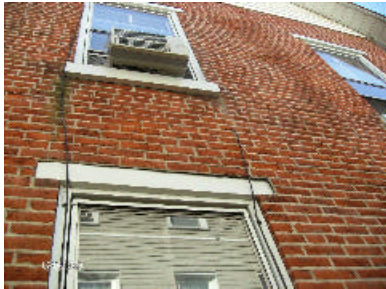
There appears to have been some outward lateral movement (Bulging) of the brick at the at the side of the house above the 2nd floor windows. Have a licensed structural engineer and/or a qualified contractor evaluate the condition and make the appropriate repairs. **\$Unknown**

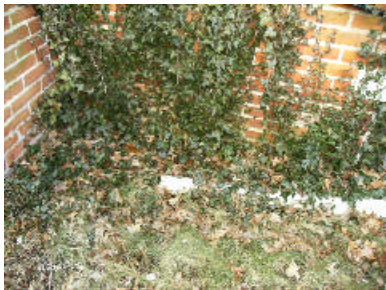
There is ivy growing on the building. Ivy as it grows and attaches itself to the building causes damage to surfaces and harbors moisture that can cause deterioration. Remove the ivy. **\$100-125**

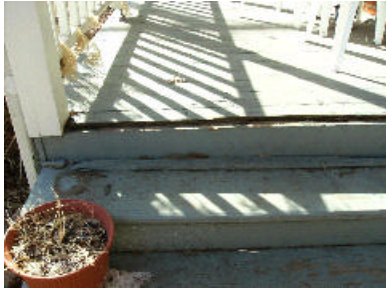
The porch has deteriorated decking material in several areas. Properly repair/replace the deck as necessary. **\$200-1500**

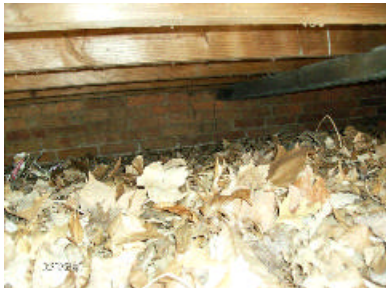
The masonry piers supporting the porch are seriously deteriorated/settling and leaning. Properly repair or restore the piers. **\$300-400**

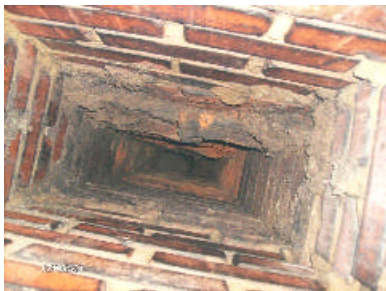
The clay flue liner servicing the oil burner in the basement is seriously deteriorated. Have an appropriate specialist install a stainless steel insert liner complete with roof cap to service the equipment. **\$1750-1900**

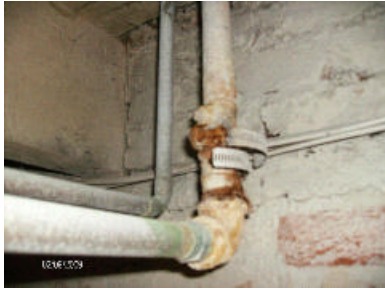
There is an improperly repaired leak in the distribution piping in the basement ceiling. Have a qualified contractor drain the system, replace the leaking pipes and refill the system as necessary. **\$300-350**

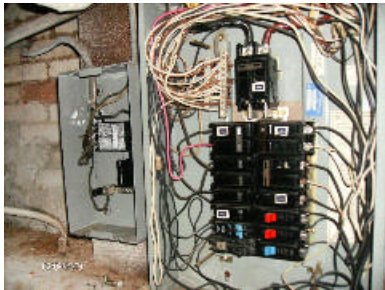
There are 3 double tapped circuit breakers/fuses in the main panel. There are ground and neutral conductors in the electric panel that improperly share the same attachment screw. The panel is also overloaded. Have a qualified electrician properly reconfigure the panels by separating the ground and neutral connections that service the same appliance, Relocate the Dryer line to the secondary panel (to free up space) and install additional properly sized circuit breakers/fuses as necessary.

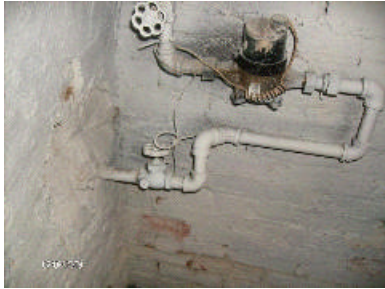
There is a ground wire attached to the water pipe is on the house side of the meter. However, there is no ground jumper wire installed at the water meter. Install a ground jumper wire with appropriate clamps attached to the water pipes at either side of the water meter.

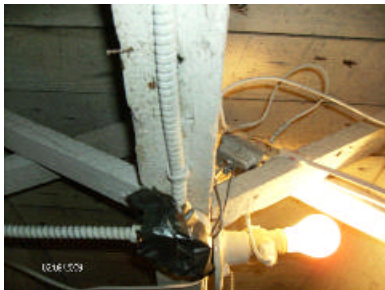
There is improperly installed wiring, open junction boxes and light fixtures that are not properly mounted in the basement ceiling. Properly rewire.

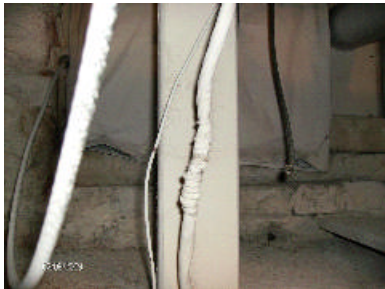
The dryer service cable is damaged near the dryer receptacle. Properly shorten the cable to remove the damaged area.

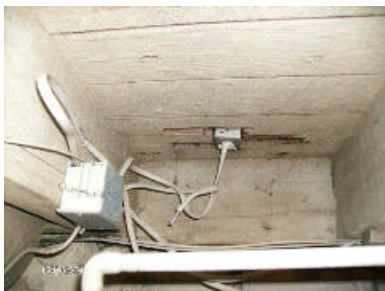
There is an improperly terminated electric cable in the in the basement ceiling below the dining room. Properly remove the cable or terminate the cable in a junction box.

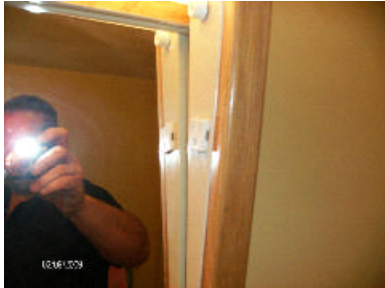
There is an outlet installed in the medicine cabinet that does not have GFCI protection. Disconnect the outlet or provide GFCI protection.

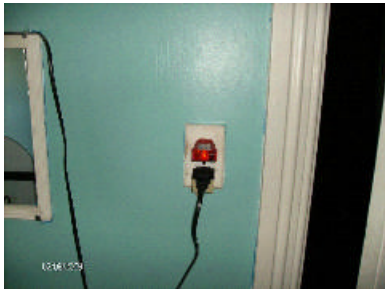
Several of the 3 prong grounded outlets throughout the house are ungrounded. Have an electrician check every outlet and correct by rewiring, reinstalling a duplex outlet or GFCI protection to correct.

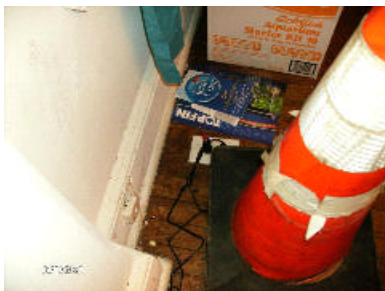
There is an improperly installed receptacle outlet in the dining room floor. Properly upgrade the outlet to one approved for use in the floor or install a metal exterior outlet cover to properly protect it from damage.

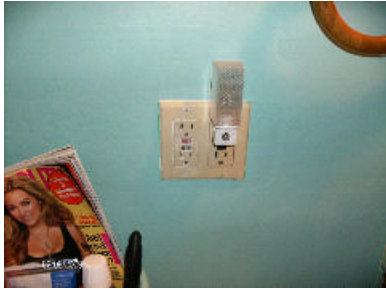
There is a Ground Fault Circuit Interrupt outlet installed in the area of the bathroom lavatory that is not properly operable. The power is on but the circuit fails to trip when tested. Replacement is necessary.

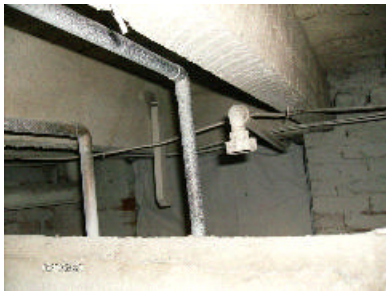
There is no Exterior Hose Bib. Properly install a hose bib to service the exterior of the building.

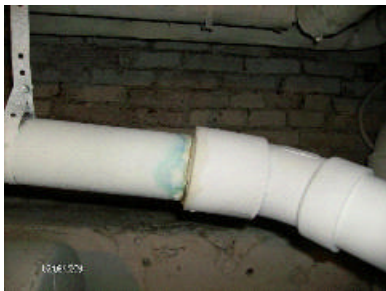
There is an improper copper to PVC drain pipe connection that is corroded and may leak. Properly install a transition coupling to make the connection.

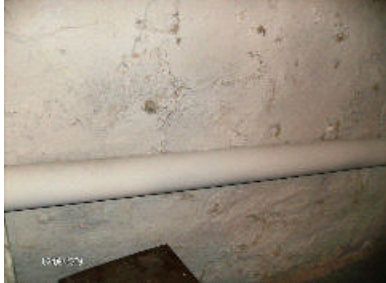
The PVC pipe installed in the basement is improperly and/or inadequately supported/installed. Install plastic or plastic coated supports every 48" maximum on every pipe as required. (Metal strapping

supports are not allowed.)

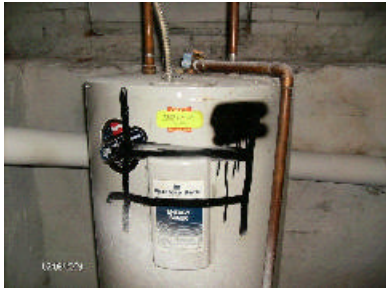
The top element access panel is not properly installed. Properly secure the access panel.

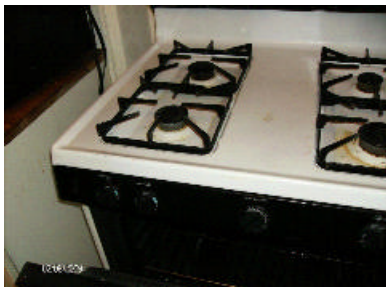
The stove has not been secured to the floor as required by manufacturer's installation instructions. A tip-over hazard exists for small children. Properly secure the stove with an anti tip bracket. \$75-100

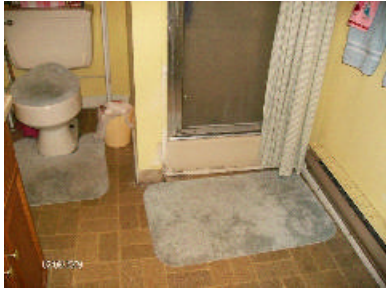
There appears to be water damage to the surfaces outside the tub/shower. Properly remove deteriorated

caulk, recaulk area and repair damages as necessary.

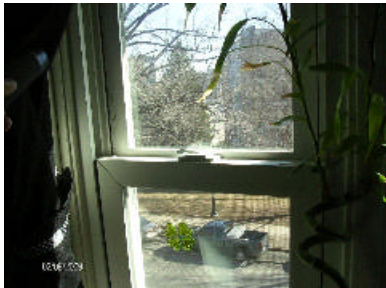
The vinyl windows do not appear to have been properly installed. There is a gap at the center of the window frame on each side of the sash. This is caused by the lack of shims being installed on either side of the window to prevent the vinyl frame from spreading or expanding into the rough opening in which the window was installed. Have a qualified contractor properly adjust the frames and shim as necessary to restore the fit of the sashes in the openings as per the manufacturers specifications.

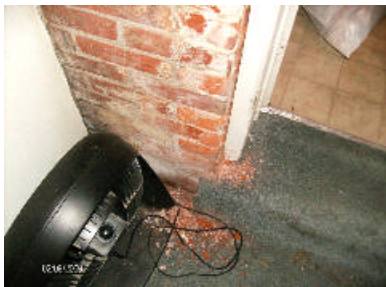
The exposed brick walls in the rear foyer are deteriorating. Remove all loose materials and apply a sealer or parge the walls to repair.

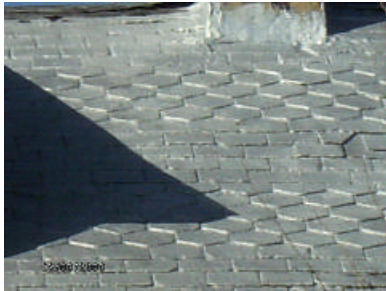
The upper front gable roof is slate. It has been coated with an aluminumized patch coating material. Budget to replace this roof in the near future. **\$3500-4500**

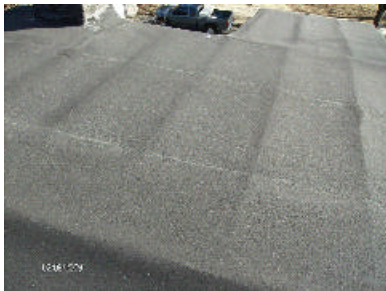
The upper rear gable and upper shed roof are covered with an elastomeric torch down material. It is showing early indications of UV damage. Properly silvercoat this roof now and every three years to extend service life. **\$350-400**

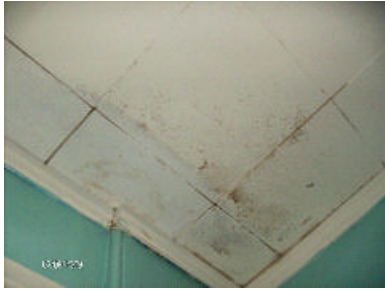
There appears to be old water stains/damage in the dressing area outside the bathroom ceiling. A moisture meter confirmed the absence of moisture.

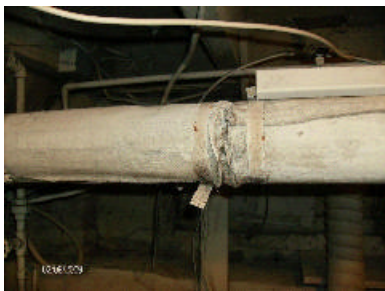
We do not do environmental inspections and you should contact a competent, responsible laboratory or asbestos mitigation contractor to be sure it is asbestos and to get opinions as to the condition and options you may have. **\$1750-2000**

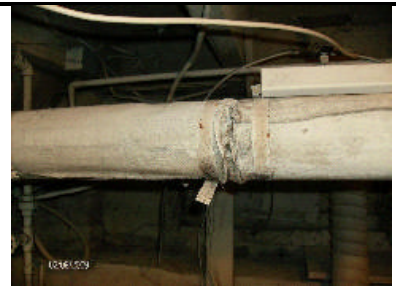
There appeared to be an asbestos type insulation present on the heating pipes, etc. We do not do environmental inspections and you should contact a competent, responsible laboratory or asbestos mitigation contractor to be sure it is asbestos and to get opinions as to the condition and options you may have.

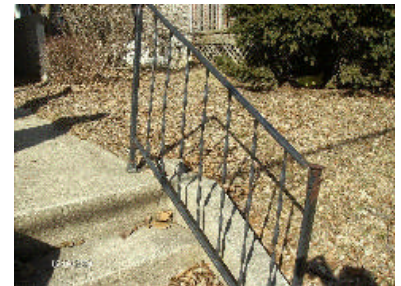
The railings servicing the front steps are deteriorated/loose. Properly repair/replace the railings as necessary.

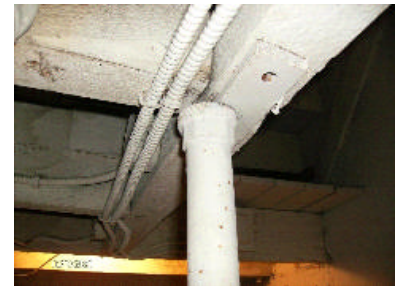
There are steel columns or posts installed that are slipping away from the plate at the top of the post> Properly realign the posts and secure them to each other.

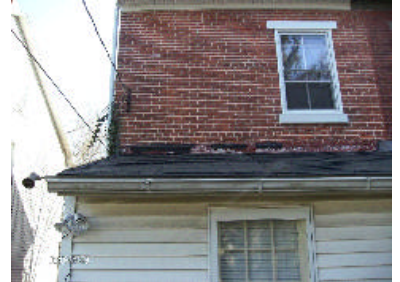
The rear counter flashing has been patched and is also beginning to rust. Repair in same manner as upper metal roof.

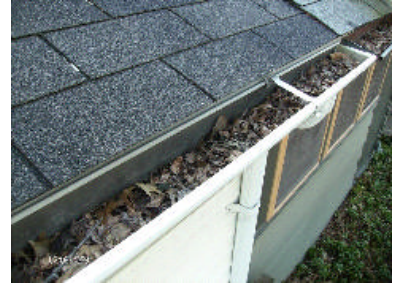
The gutters and downspouts are full of debris and overflowing at the rear of the property. Properly clean and maintain the gutters and downspouts.

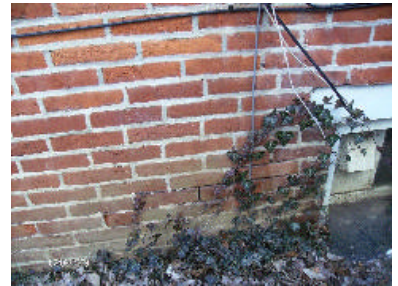
The exterior brick surfaces have minor deteriorated mortar joints at several areas. Have a masonry specialist properly repair/repoint and preserve the brick as necessary.

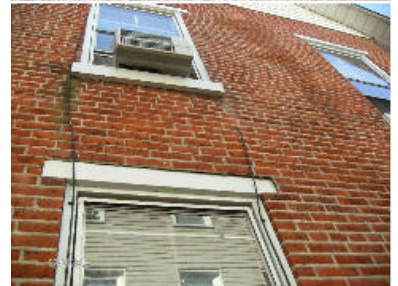
There is ivy growing on the building. Ivy as it grows and attaches itself to the building causes damage to surfaces and harbors moisture that can cause deterioration. Remove the ivy.

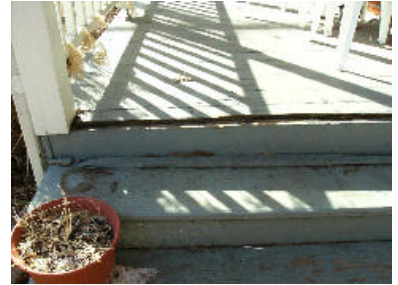
The porch has deteriorated decking material in several areas. Properly repair/replace the deck as necessary.

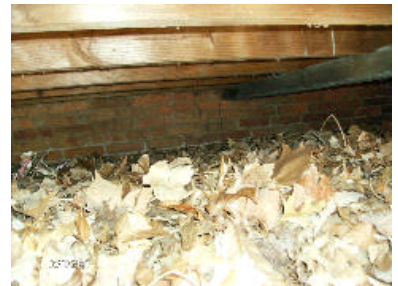
The masonry piers supporting the porch are seriously deteriorated/settling and leaning. Properly repair or restore the piers.

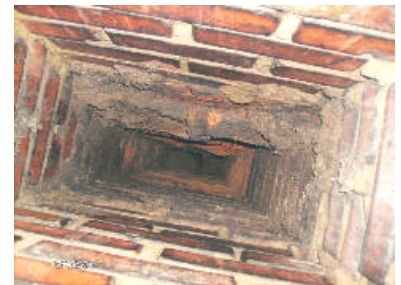
The clay flue liner servicing the oil burner in the basement is seriously deteriorated. Have an appropriate specialist install a stainless steel insert liner complete with roof cap to service the equipment.

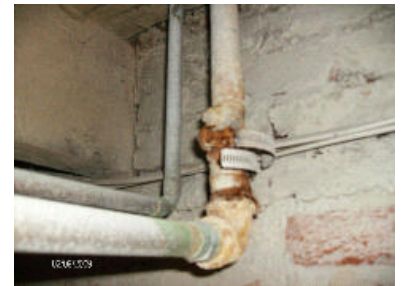
There is an improperly repaired leak in the distribution piping in the basement ceiling. Have a qualified contractor drain the system, replace the leaking pipes and refill the system as necessary.

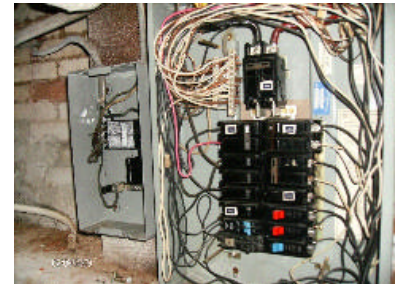
There are 3 double tapped circuit breakers/fuses in the main panel. There are ground and neutral conductors in the electric panel that improperly share the same attachment screw. The panel is also overloaded. Have a qualified electrician properly reconfigure the panels by separating the ground and neutral connections that service the same appliance, Relocate the Dryer line to the secondary panel (to free up space) and install additional properly sized circuit breakers/fuses as necessary.

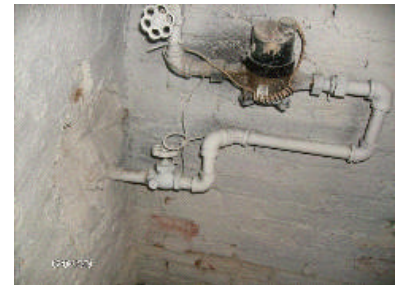
There is a ground wire attached to the water pipe is on the house side of the meter. However, there is no ground jumper wire installed at the water meter. Install a ground jumper wire with appropriate clamps attached to the water pipes at either side of the water meter.

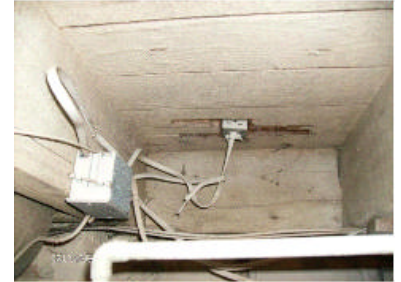
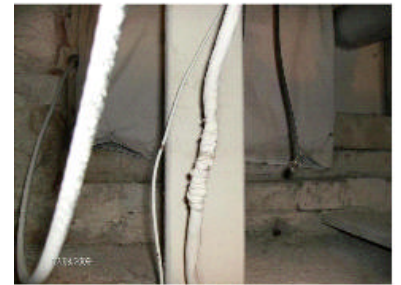
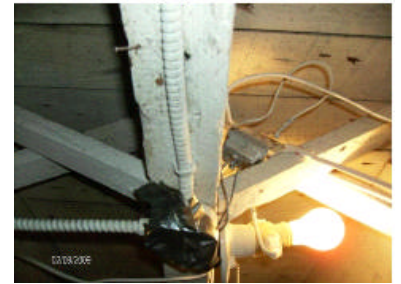
There is an improperly terminated electric cable in the in the basement ceiling below the dining room. Properly remove the cable or terminate the cable in a junction box.

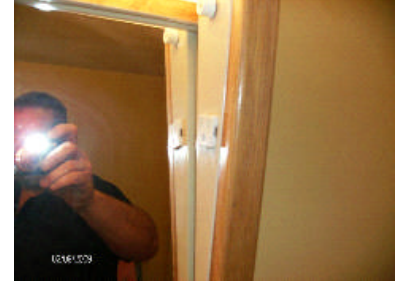
There is an outlet installed in the medicine cabinet that does not have GFCI protection. Disconnect the outlet or provide GFCI protection>

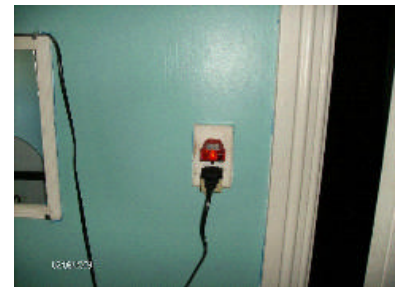
Several of the 3 prong grounded outlets throughout the house are ungrounded. Have an electrician check every outlet and correct by rewiring, reinstalling a duplex outlet or GFCI protection to correct.

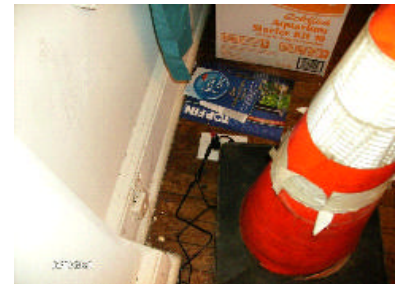
There is an improperly installed receptacle outlet in the dining room floor. Properly upgrade the outlet to one approved for use in the floor or install a metal exterior outlet cover to properly protect it from damage.

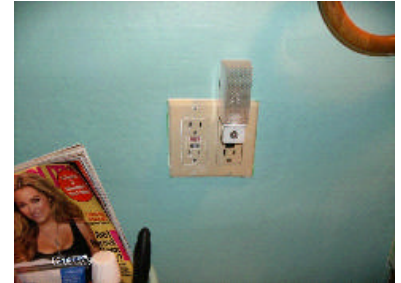
There is a Ground Fault Circuit Interrupt outlet installed in the area of the bathroom lavatory that is not properly operable. The power is on but the circuit fails to trip when tested. Replacement is necessary.

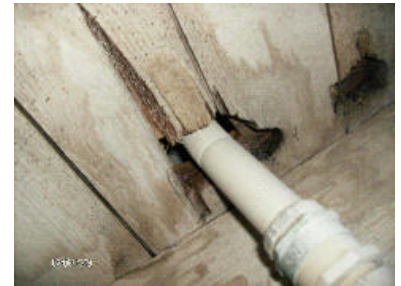
The sink drain trap line extends through the floor before it discharges into the main sewer pipe. Properly extend the main drain pipe through the floor and into the cabinet to allow for installation without a trap extension.

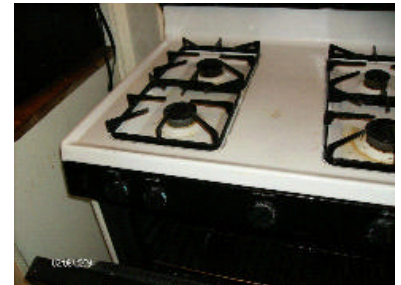
The stove has not been secured to the floor as required by manufacturer's installation instructions. A tip-over hazard exists for small children. Properly secure the stove with an anti tip bracket.

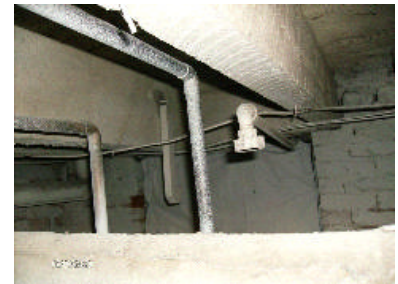
There is no Exterior Hose Bib. Properly install a hose bib to service the exterior of the building.

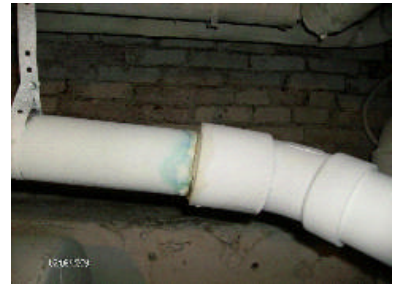
There is an improper copper to PVC drain pipe connection that is corroded and may leak. Properly install a transition coupling to make the connection.

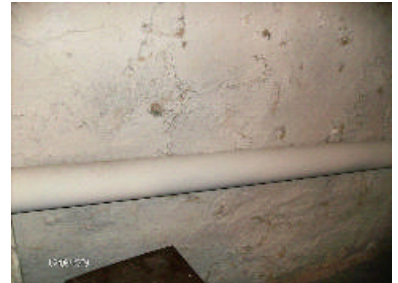
The PVC pipe installed in the basement is improperly and/or inadequately supported/installed. Install plastic or plastic coated supports every 48" maximum on every pipe as required. (Metal strapping supports are not allowed.)

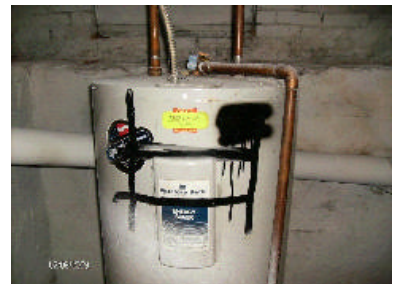
The top element access panel is not properly installed. Properly secure the access panel.

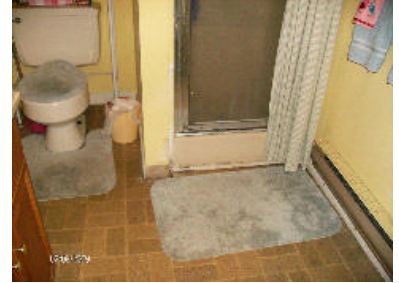
There appears to be water damage to the surfaces outside the tub/shower.
Properly remove deteriorated caulk, recaulk area and repair damages as necessary.

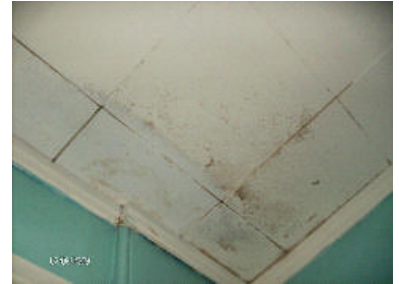
There appears to be old water stains/damage in the dressing area outside the bathroom ceiling. A moisture meter confirmed the absence of moisture.

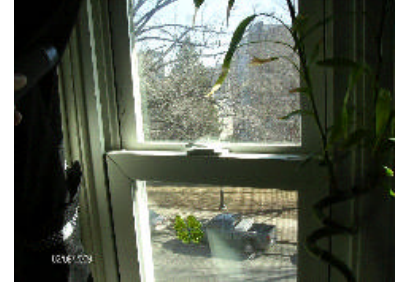
The vinyl windows do not appear to have been properly installed. There is a gap at the center of the window frame on each side of the sash. This is caused by the lack of shims being installed on either side of the window to prevent the vinyl frame from spreading or expanding into the rough opening in which the window was installed. Have a qualified contractor properly adjust the frames and shim as necessary to restore the fit of the sashes in the openings as per the manufacturers specifications.

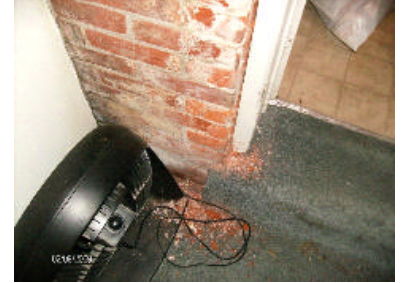
The exposed brick walls in the rear foyer are deteriorating. Remove all loose materials and apply a sealer or parge the walls to repair.
