Inspection Report

Client: Matthew Masters

**Property Address:
206 Sporting La
Radnor PA 19087**

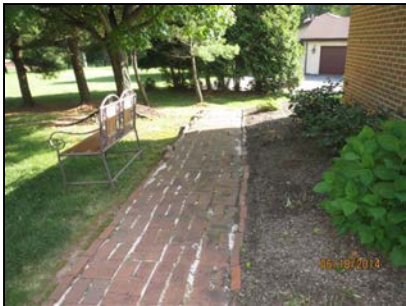
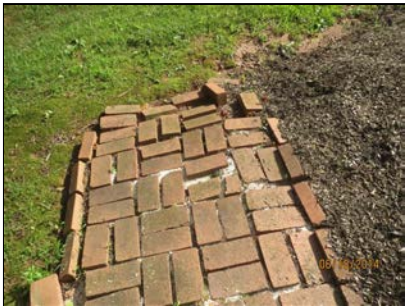
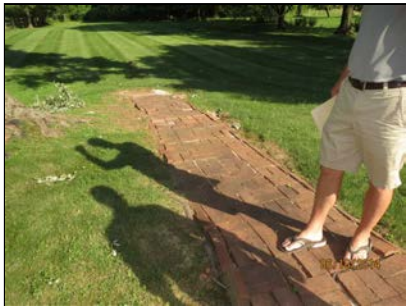
The sidewalks/walkways appear to have a problem. There are sections of walkway that have settled creating an uneven and unsafe walking surface. Properly correct as necessary.

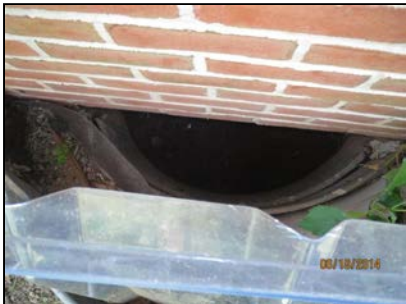
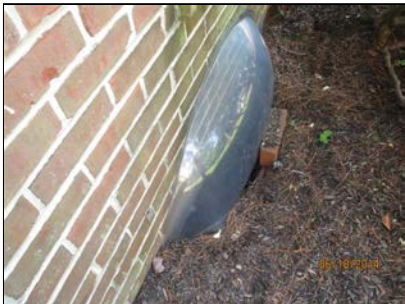
(1) The window wells on the left side and rear of the building are too short and have been flattened. Tear out and install new window well walls that extend up to at least the first course of brick. The floor of the window well should be at least 6" below the window sill filled with 2" of stone. Install covers when done.

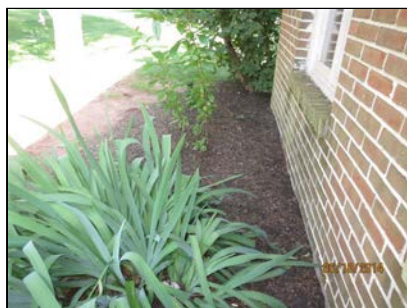
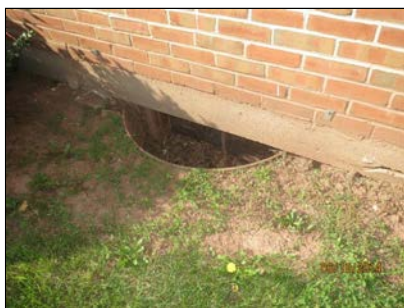
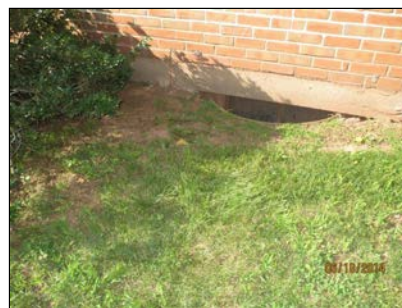
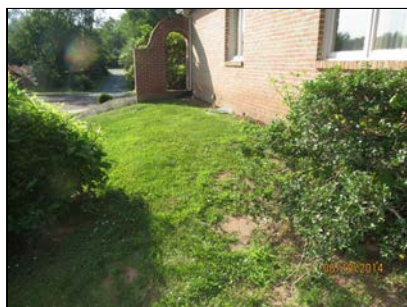
(2) There is negative grading present at the left side (facing front), rear of home and right side (facing front) area outside the building. This could cause water penetration issues in the lower level and deterioration to the structure. Properly regrade the area to prevent ponding along the foundation. Well over 95% of water penetration problems into below grade areas of a home are due to surface water that is not managed properly. When grades slope towards the walls of the house they allow water to accumulate at the walls of the house. The worst areas are typically at downspouts, window wells, and adjacent to exterior steps. The gutter and downspout systems also contribute to water accumulation problems. The problem is rarely due to a high water table, because, homes are typically not built with below grade areas when the water table is high. I.e.: Generally areas close to sea level.

- Remove soft or porous soils, stone or gravel, top soil, mulch and wood chips, etc. from the areas that need regrading. Areas that need regrading will typically be the low areas where water may be accumulating. The top soils and other soft materials can be reused when the new grades are developed. Using stone or gravel is not recommended because they do not divert water.

- In situations where this type of regrading is not a reasonable option, an interior hydrostatic pressure relief system with a sump pump maybe necessary. These systems do not stop the water penetration, however, they are an effective way to control water that enters by receiving it and discharging it to the exterior. Some basements or crawl spaces may have elevated relative humidity with this type of system.

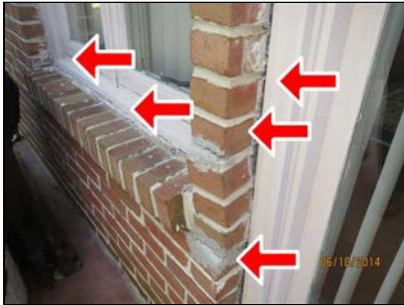
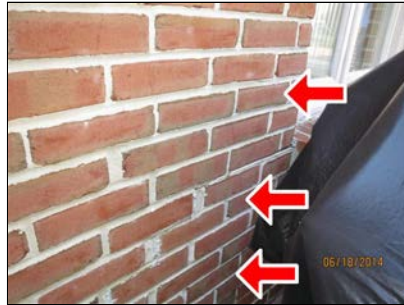
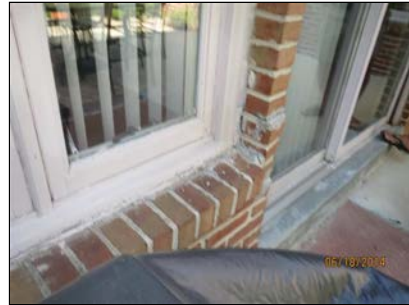
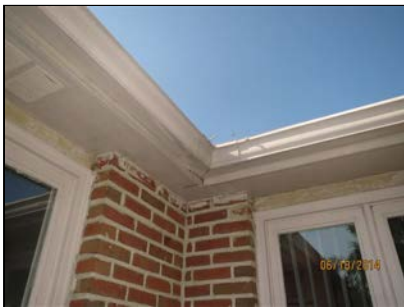
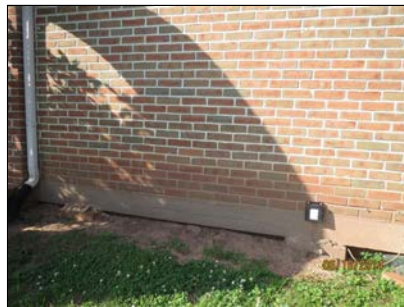
The brick veneer is cracked, settled and deteriorating in many areas especially at the rear patio and along the right side of the building. Have a masonry specialist properly restore.

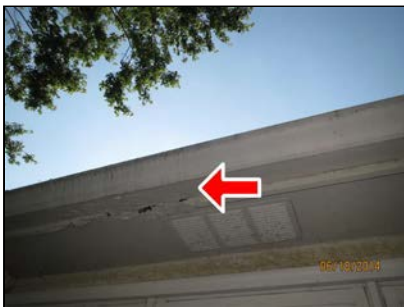
**1.4 Trim, Soffit and Fascia**

There is deteriorated trim at several areas around the exterior of the building. Remove all deteriorated trim, repair the internal support structure as necessary and properly install new trim, caulk, prime and paint as necessary.

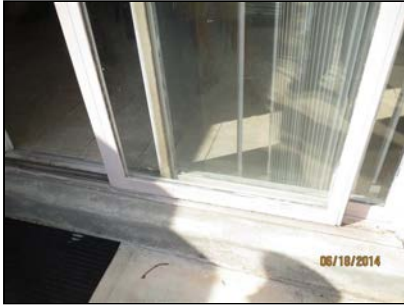
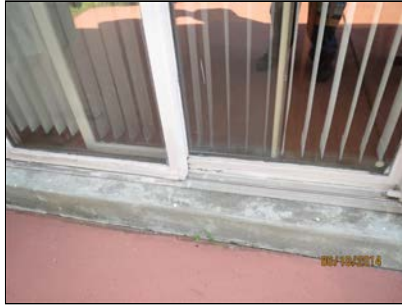
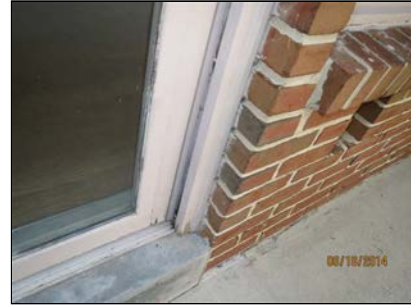
(1) The side and rear entry slider doors are deteriorated. The frame/door or threshold is seriously deteriorated due to prolonged exposure and inadequate maintenance. Have a qualified contractor properly repair/rebuild/replace as necessary..

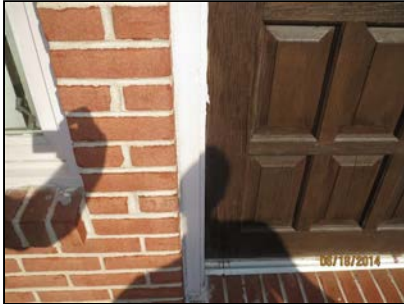
(2) The main entry door is deteriorated. The frame/door or threshold is seriously deteriorated due to prolonged exposure and inadequate maintenance. . Have a qualified contractor properly repair/rebuild/replace as necessary..

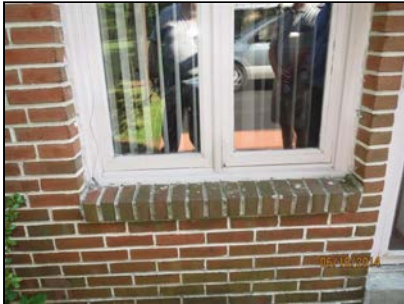
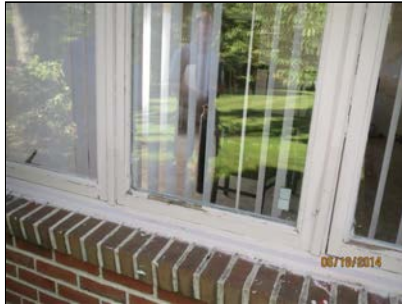
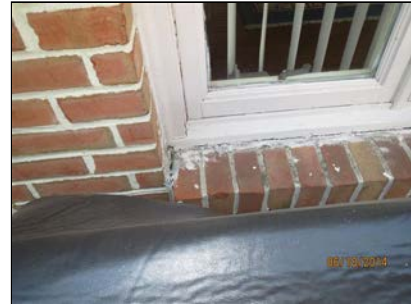
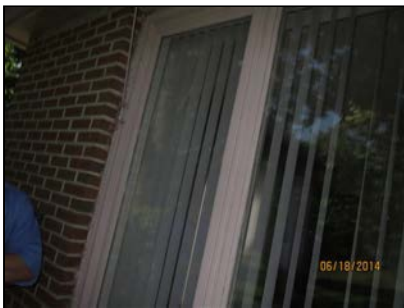
1.7 Exterior Windows

There appears to be a problem with the windows in the throughout the house. There are several windows exhibiting various stages of deterioration. There is deteriorating wood framing/trim, gaskets and hardware on the exterior surfaces as well as deteriorating finishes. Properly repair and refinish as necessary.

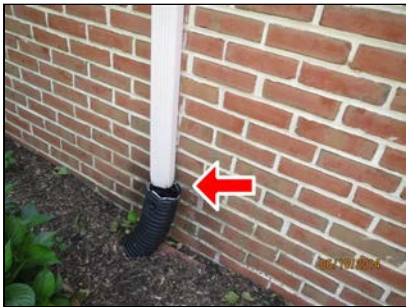
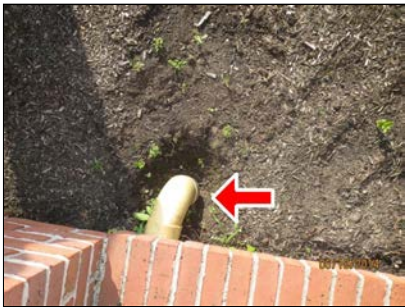
- (1) Gutters and downspouts need to be checked, cleaned out and maintained on a regular basis. This should be done at least twice a year and more often as conditions warrant. Maintaining control of the runoff around the perimeter of the building is important to the safety of the building and its occupants.
- (2) There is/are missing sections of gutters and/or downspouts at the front of home and rear of home. Properly repair/replace.

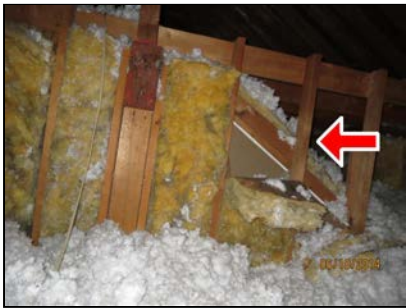
There is wall insulation that is coming loose. Properly reinstall and add strapping to hold it in place.

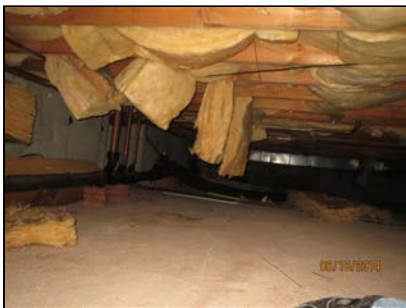
There are insulation batts that have fallen down exposing the living space to the unconditioned areas. Properly reinstall and secure the batts

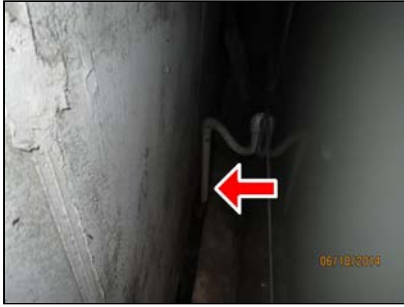
(3) There appears to be a problem at the interior coil unit. The condensate discharges directly into the open trough between the foundation and floating slab. Properly redirect the condensate to a drain, sink or the exterior.

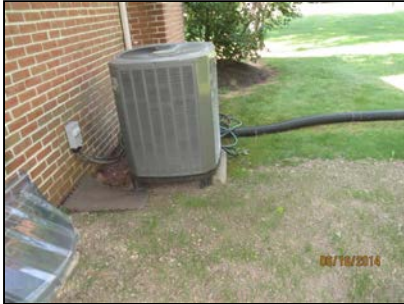
(4) There appears to be a problem at the exterior condenser unit. The outside condenser is not set on a level base. Properly reset the unit on a level base.

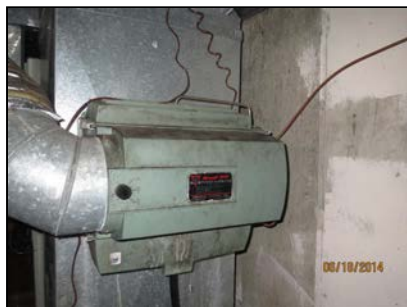
There is an abandoned humidifier. Remove and properly sealing the open ductwork.

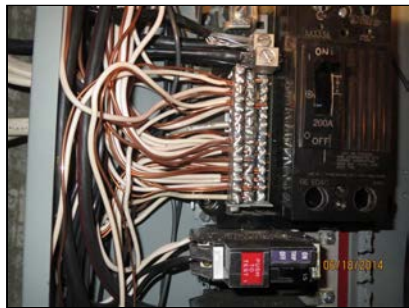
(2) There appears to be a wiring problem in the service panel that calls for immediate action. There are ground and neutral conductors or just neutral conductors in the main service panel that improperly share the same attachment screw. Properly separate the ground and neutral conductors with each conductor attached by independent screws.

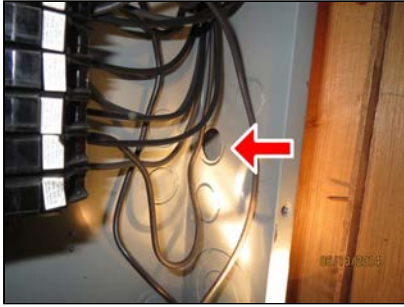
(3) The main service panel and/or its components requires immediate action to minimize the possibility of electrical shock. There are missing knock-outs in the panel enclosure. Properly cap/seal openings.

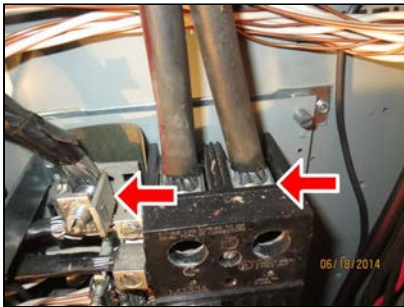
There is no antioxidant paste present coating the aluminum conductors/connections in the electric panel. The aluminum conductors where the conductors make connections should be coated with an antioxidant paste to prevent corrosion to the contacts. Correct as necessary.

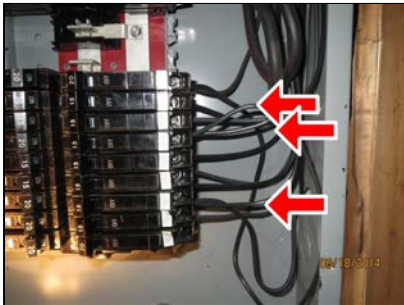
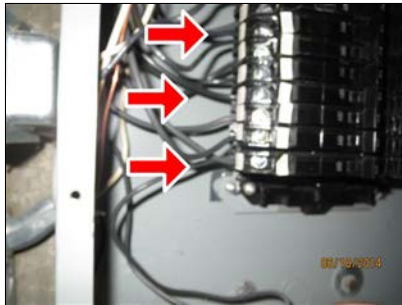
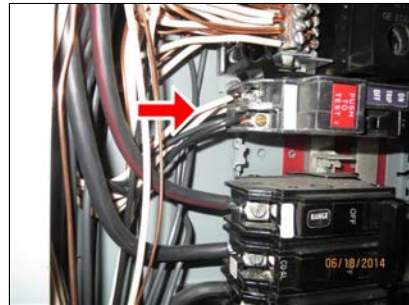
There appears to be a problem with the circuit breakers/fuses in the service panel that calls for immediate action. There are double tapped circuit breakers/fuses in the main panel. This situation occurs when there is more than one electric cable/circuit attached and protected by the same circuit breakers/fuses. The double tapped circuit limits the ability of each circuit to perform and protect as designed.

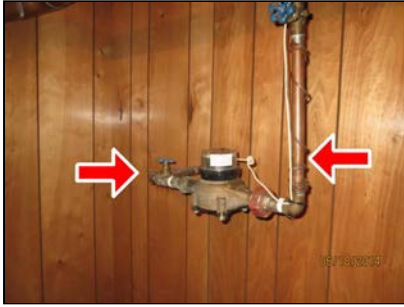
There is no ground jumper wire installed across the water meter to allow for proper bonding of the plumbing in the building with the public water supply. Install appropriate ground clamps and jumper wire as necessary.

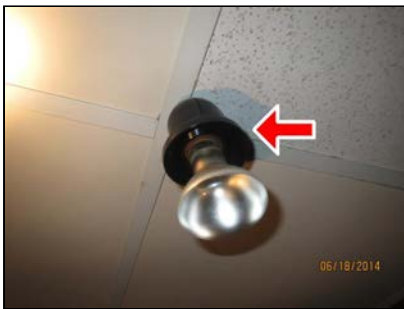
The cable servicing the light fixture is not properly installed/deteriorated. Properly correct.

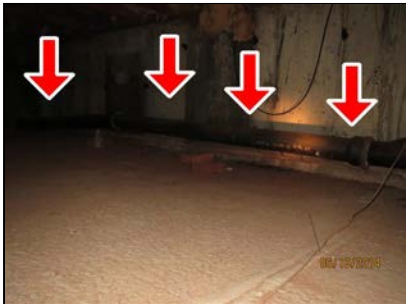
The plumbing waste line is not properly supported. in the crawlspace. . A qualified person should repair as necessary.

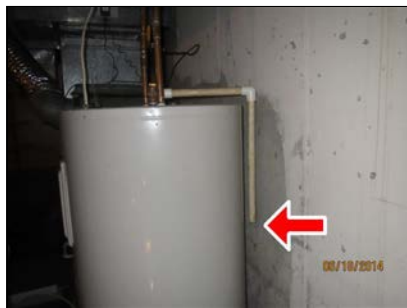
(1) There is an TPR Valve overflow pipe installed, but it does not extend to within 6" of the floor. A 3/4" extension pipe should be installed on the Temperature Pressure Relief (TPR) valve and should terminate within 6" of the floor.

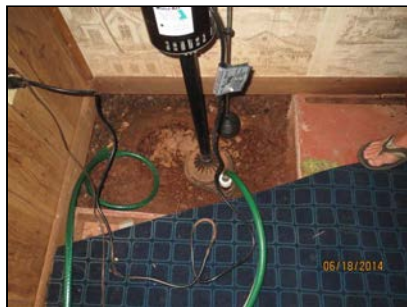
(1) The sump pump is installed in a shallow mud pit. Properly deepen and install an appropriately sized sump basin and reinstall the pumps as necessary with appropriate piping and check valves.

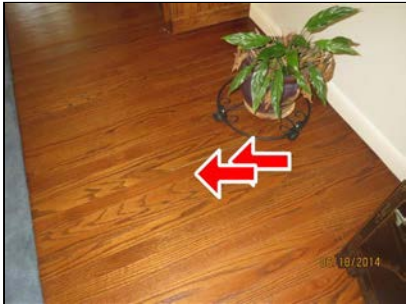
The Wood floor is damaged at the Living Room. Properly repair/replace as necessary.. .

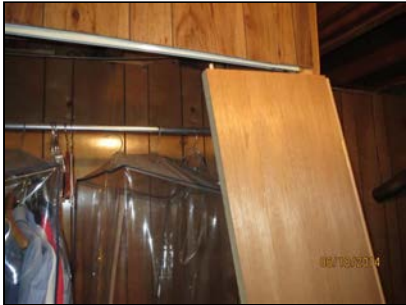
(1) The closet door(s) have a problem. Several of the bifold doors are not properly installed or are not properly operable. Correct as necessary.

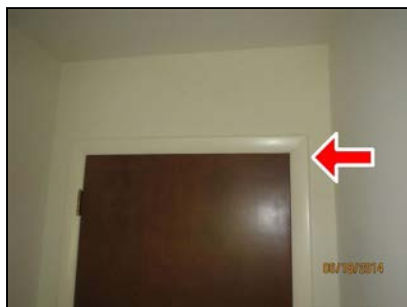
(2) There are many interior doors installed throughout the house that do not close and latch properly. Have a qualified contractor properly sand, plane, adjust and modify as necessary to allow for proper operation.

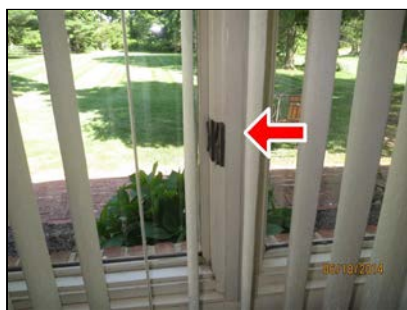
There appears to be a problem with the windows in the Bedroom. There are windows with broken and/or missing sash locks. Properly repair or replace the locks as necessary.

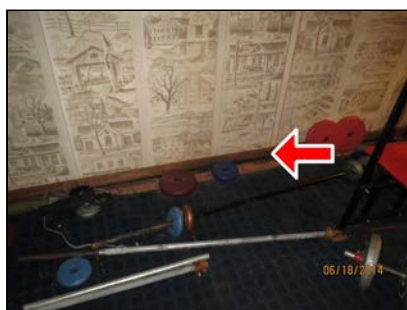
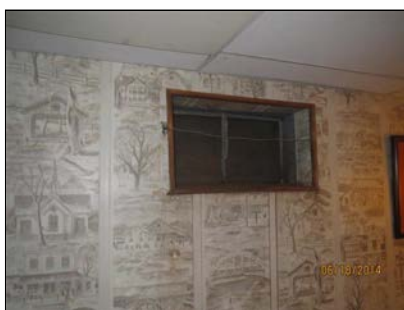
(1) There is water damage to the walls, flooring and framing at the rear and left sides of the building. See Site and Exterior for grading issues and properly repair/replace and restore the inside.

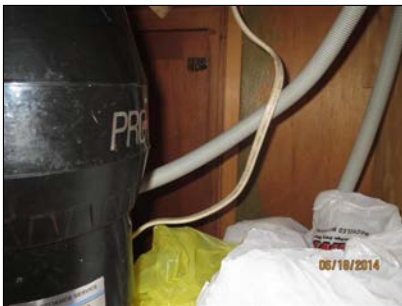
(2) The dishwasher drain line is improperly installed. The Drain line does not have an air gap which prevents water from backfilling the dishwasher from draining water from the sinks. Reinstall the drain line with the line secured to the bottom of the counter top above the rim of the sink to provide the necessary air gap.

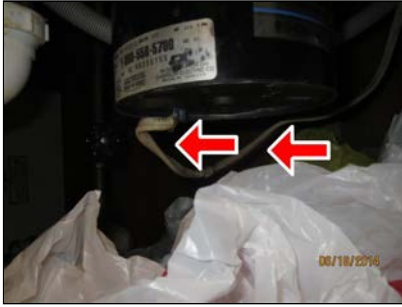
(2) The disposal is not wired properly/safely. Properly rewire the disposal.

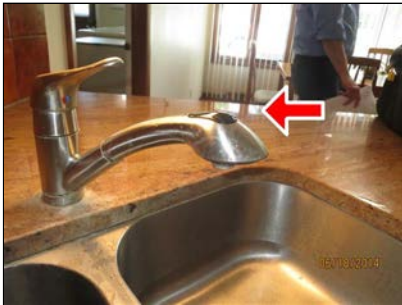
(1) The faucet/sprayer is not properly operable. Repair/replace as necessary.

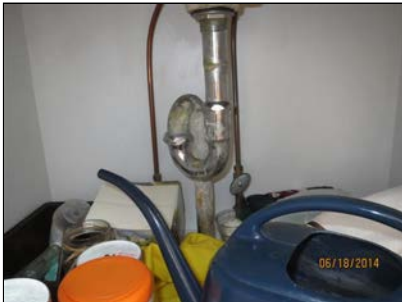
(2) There is corrosion on the sink trap or drain line in the powder room. This is an early indication of failure. Properly replace the drain/trap as necessary.

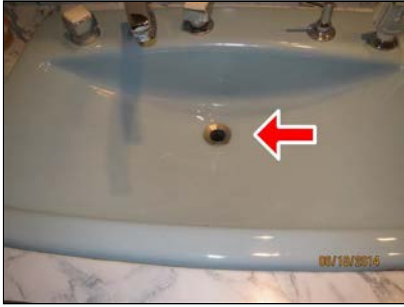
(3) The bathroom sink drain popup assembly is not properly operable. Repair as necessary.

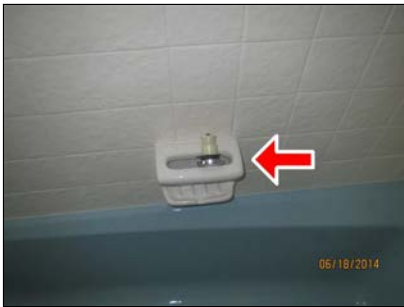
There appears to be a problem with the Bathtub in the master bath. The tub drain stopper assembly is not properly operable. Properly repair/replace the stopper assembly.

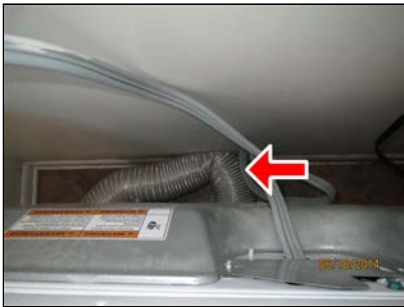
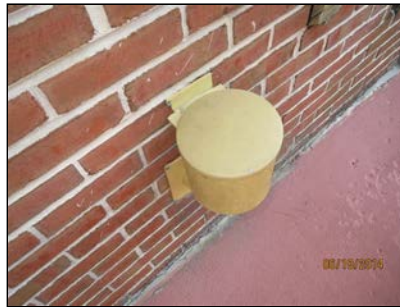
There is a damaged vent outlet at the exterior of the building. Properly repair/replace the vent outlet. The dryer exhaust pipe has been crushed. This will seriously affect dryer performance and is a fire safety issue. Properly replace the dryer exhaust line.

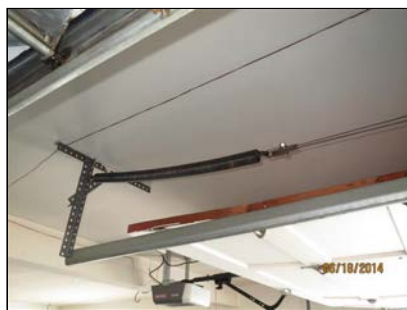
There are no safety cables installed inside the garage door springs. These cables are intended to keep the spring when it fails from becoming a dangerous projectile. Properly install appropriate safety cables inside each spring.

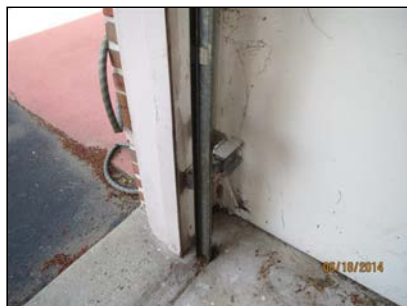
(1) The electric eyes installed at the garage door are installed too high. Properly reinstall the eyes at 4-6" above the floor.

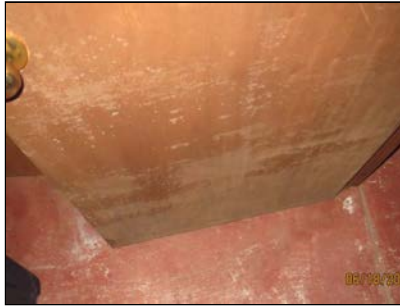
There is mold/mildew on the subfloor below the hall bath shower and on some doors/paneling in the basement. Properly clean and treat the area.
