Inspection Report

Client: Matthew Masters

**Property Address:
206 Sporting La
Radnor PA 19087**

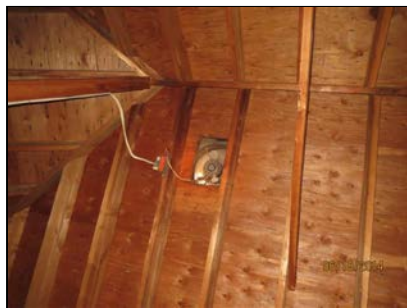
Yes - There is an attic ventilation fan installed. It is thermostatically activated, and it was not tested as a part of this inspection. The inspector does not override automatic controls as a part of the inspection.

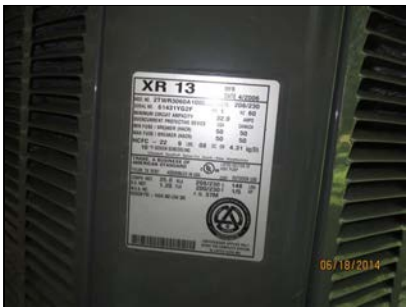
(2) Satisfactory. The heat pump when operated produced between 15 and 20 degrees of temperature differential and a back-up temperature of 30+ degrees, which is within acceptable limits to expect proper operation.

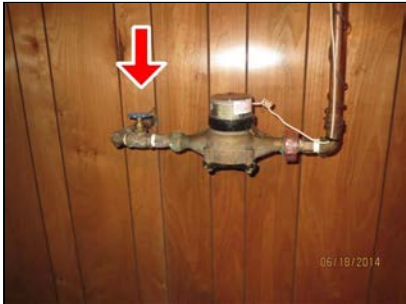
The water shutoff is located in the basement on the front wall.

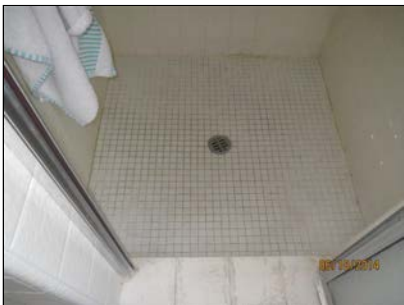
Disclaimer - This is a visual inspection of the readily accessible portions of the shower stall. The shower pan below the tile is concealed and therefore its condition cannot be evaluated. Consider the need for replacement in the future with little or no notice.
